RRD23MR005

## Norfolk Southern Railway Train Derailment with Subsequent Hazardous Material Release and Fires

#### Preliminary Report: February 23, 2023

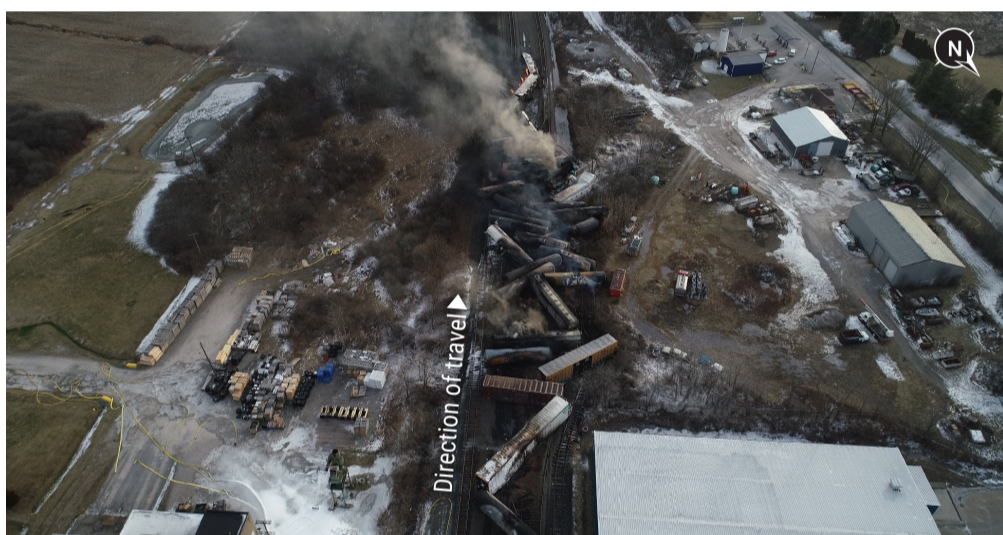
On February 3, 2023, about 8:54 p.m. local time, eastbound Norfolk Southern Railway (NS) general merchandise freight train 32N derailed 38 railcars on main track 1 of the NS Fort Wayne Line of the Keystone Division in East Palestine, Ohio. [1] (See figure.) The derailed equipment included 11 tank cars carrying hazardous materials that subsequently ignited, fueling fires that damaged an additional 12 non-derailed railcars. First responders implemented a 1-mile evacuation zone surrounding the derailment site that affected up to 2,000 residents. There were no reported fatalities or injuries. At the time of the accident, visibility conditions were dark and clear; the weather was 10°F with no precipitation.
